A BRIEF REPORT ON RELIEF WORKS UNDERTAKEN
IN
EARTHQUAKE-1991 AFFECTED AREAS OF
DISTRICT- UTTARKASHI

Garhwal Earthquake of Oct. 20, 1991

EERI Special Earthquake Report, EERI Newsletter, Vol.26, No.2, February 1992

Sudhir. K. Jain, Ramesh P. Singh, Vinay K. Gupta and Amit Nagar
Department of Civil Engineering
Indian Institute of Technology Kanpur

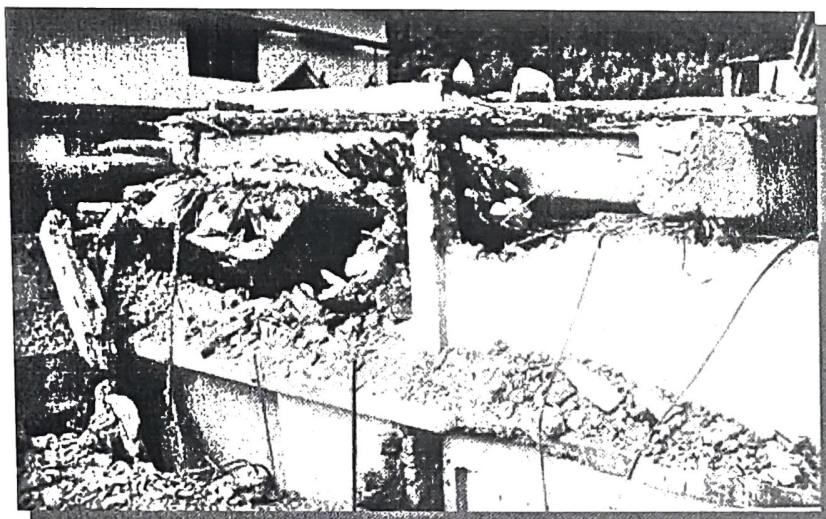
Figure 2: State Bank Building at Uttarkashi

Figure 2 shows the State Bank building in Uttarkashi. During the earthquake, the upper two stories collapsed on the first story. Informations from the local residents revealed that the building was first constructed as one story only; the upper two story was added subsequently. The beams has only two normal rebars on the top face near the column joint and those were incorrectly placed.

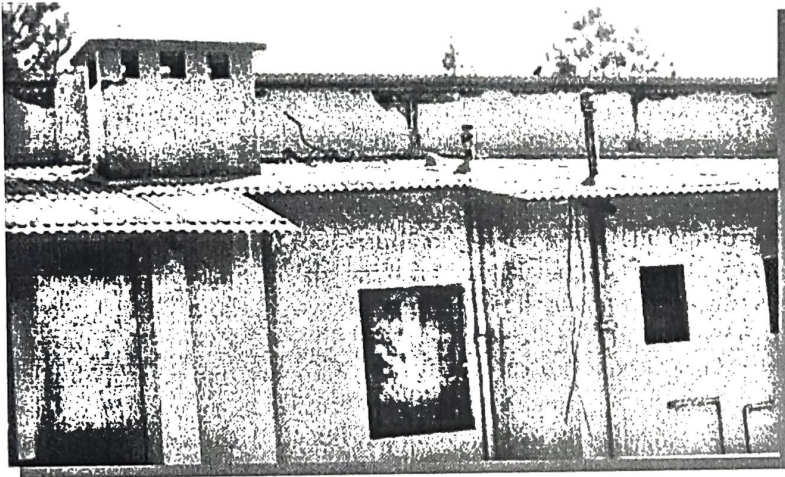
Figure 3: Damage to wall supporting Split Level roof - ITBP campus, Mahidanda.

The ITBP Paramilitary Campus at Mahidanda consists a large number of two story residential buildings with load bearing walls of concrete masonry. All have

RC lintel bands, but no roof bands or gable bands. The construction is about 10 years old. The damage to buildings consisted of (i) diagonal cracks below window sills, (ii) damage at the connection between masonry walls and RC roof slabs, (iii) in buildings with corrugated iron sheet roofs, damage at seat of purlins on the gable end walls, and (iv) damage to walls supporting roofs at different heights at either end (*Figure 3*). Roof and gable bands would have prevented damage of types (ii), (iii), and (iv) above.

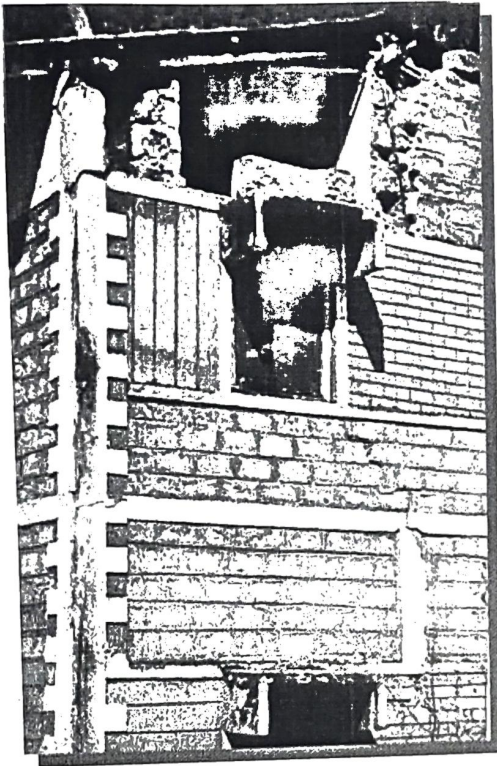
Figure 4: Damage to Gable Wall -Maneri Hydel Project Colony

The Maneri Hydel power project colony campus has two-storey buildings with concrete block masonry bearing walls, of poorer quality construction than that seen on the ITBP campus. Many buildings were damaged beyond repair. Damage consisted of (i) severe damage to gable walls (*Figure 4*), and (ii) diagonal cracks in ground story walls.

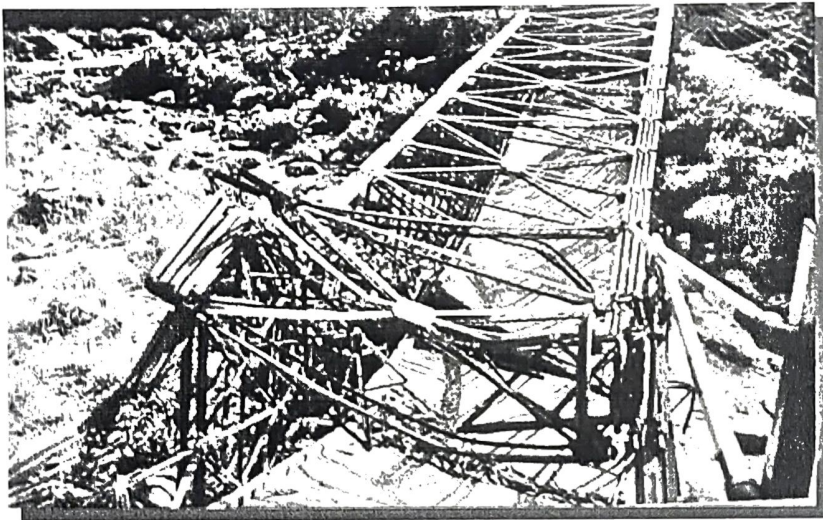
Figure 5: Collapsed Gwana bridge

The Gawana Bridge is a 56.0 m span steel truss bridge build in 1974. It is located at 6km from Uttarkashi towards Maneri. The entire bridge came off the abutments and fell into the river (*Figure 5*) causing the entire area beyond Uttarkashi to be cut off from the rest of the country. Inadequate design of the bearings and anchor bolts as well as absence of any suitable means of preventing the span from falling off the supports were responsible for the damage.

The peak horizontal ground acceleration in the region was about 0.30 g. The Indian codes specifies the design seismic force for bridges in the range of 0.05 to 0.075 g for zone IV. This is obviously inadequate. It is hoped that the bridge failures caused by this earthquake will provide the necessary impetus to revise the code.

provide some useful insight after detailed analysis. There was enormous loss due to landslides and collapse of retaining walls. The failure of Gowana bridge needs to be studied. This may trigger revision of the Indian code.
