**Silkyara-Barkot Tunnel (Uttarkashi)**

**Collapsed Disaster**

**Uttarakhand State Disaster Management Authority,  
Uttarakhand, India**

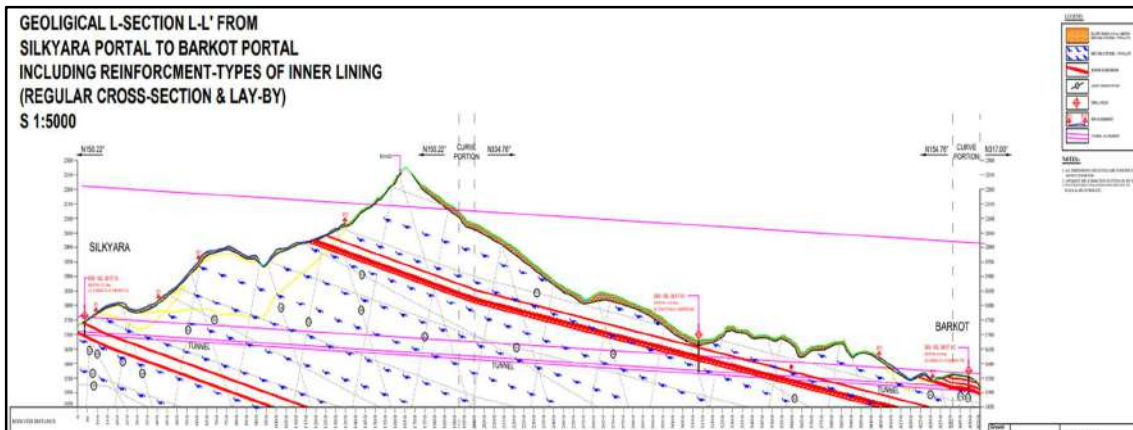
Figure 4: Geological section along the tunnel length

A collapse zone has been identified approximately 200 meters from the tunnel portal. The rock in this area exhibits characteristics of a shear zone, as illustrated in Figure 4. The rock is fine-grained, dark grey, and has alternating bands of chloritic phyllite and siltstone, predominantly dominated by siltstone and thin to moderately foliated. The subsidence is occurring in the hanging wall of the shear zone, indicating a vulnerability in this specific geological formation.

Notably, two distinct shear zones are evident as we move toward the tunnel portal. The first shear zone is marked at 1700 meters from the portal, and the second is identified at 1748 meters, approximately 150 meters from the portal. Both shear zones align parallel to the foliation planes of the rock, emphasizing the significance of geological considerations in understanding and mitigating the risks associated with subsidence and collapse in the tunnel construction project. From the available face logs, the 3D geological log is prepared for the shear zone in this reach to get a first-hand assessment. The shear zone thickness is 100cm at some places containing pulverized and crushed rock mass.

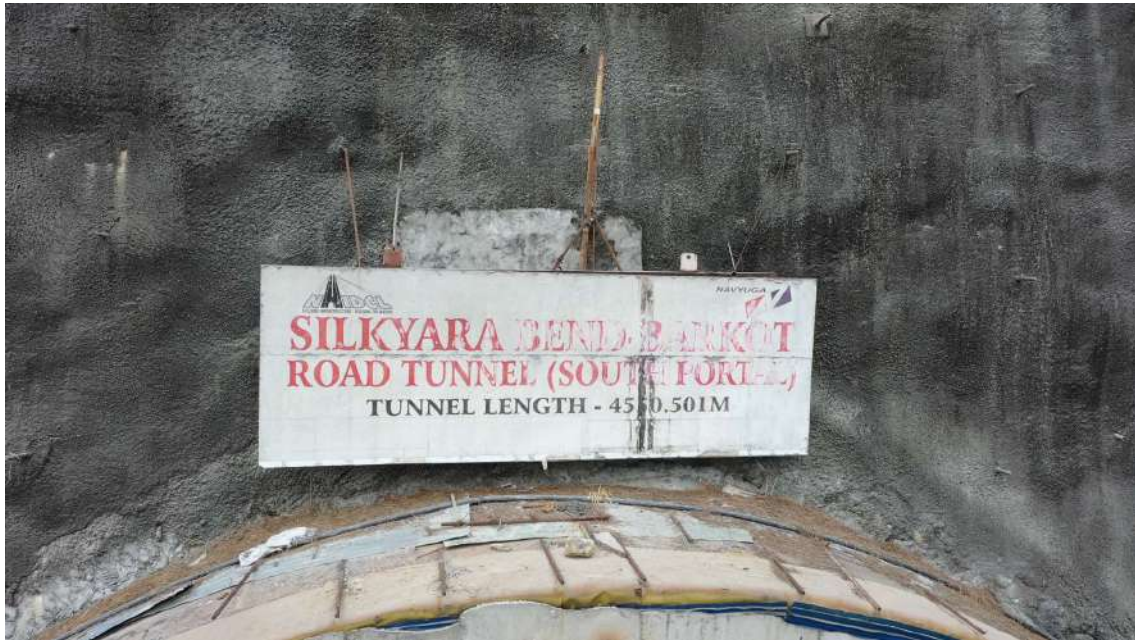
**In Figure 5, the images of the upper portion of the tunnel provide a visual representation, showcasing the total length of the tunnel at 4550.501 meters.**

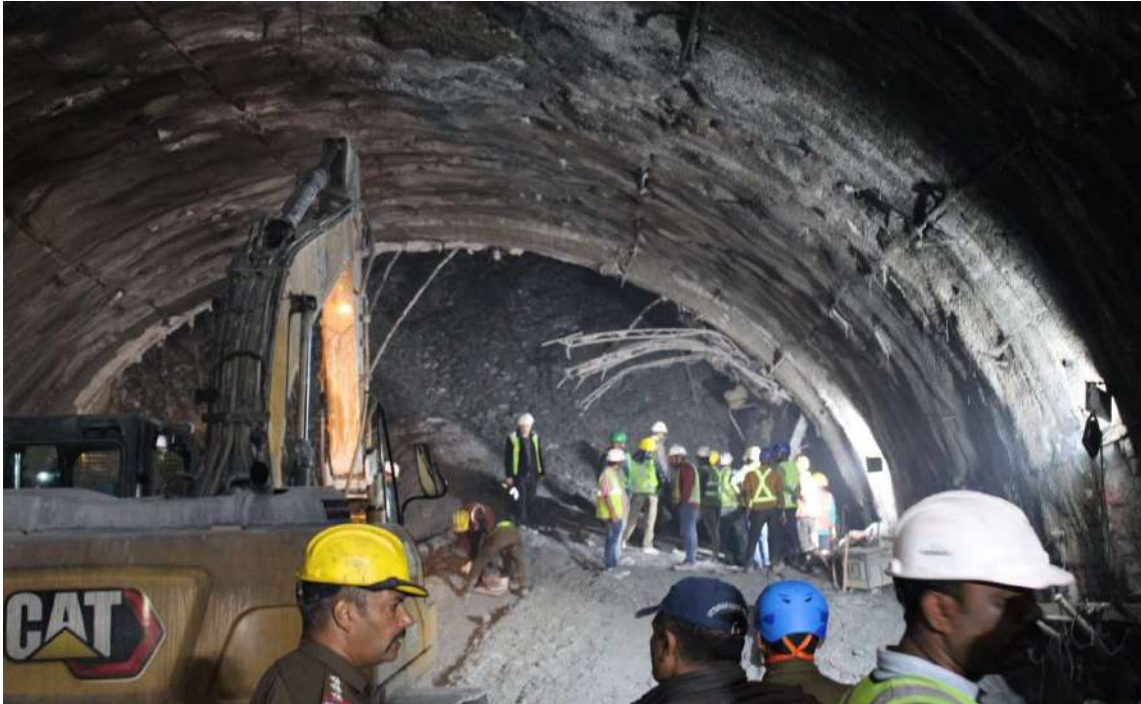
**Figure 7 illustrates the conditions within the tunnel on December 14, 2023.**

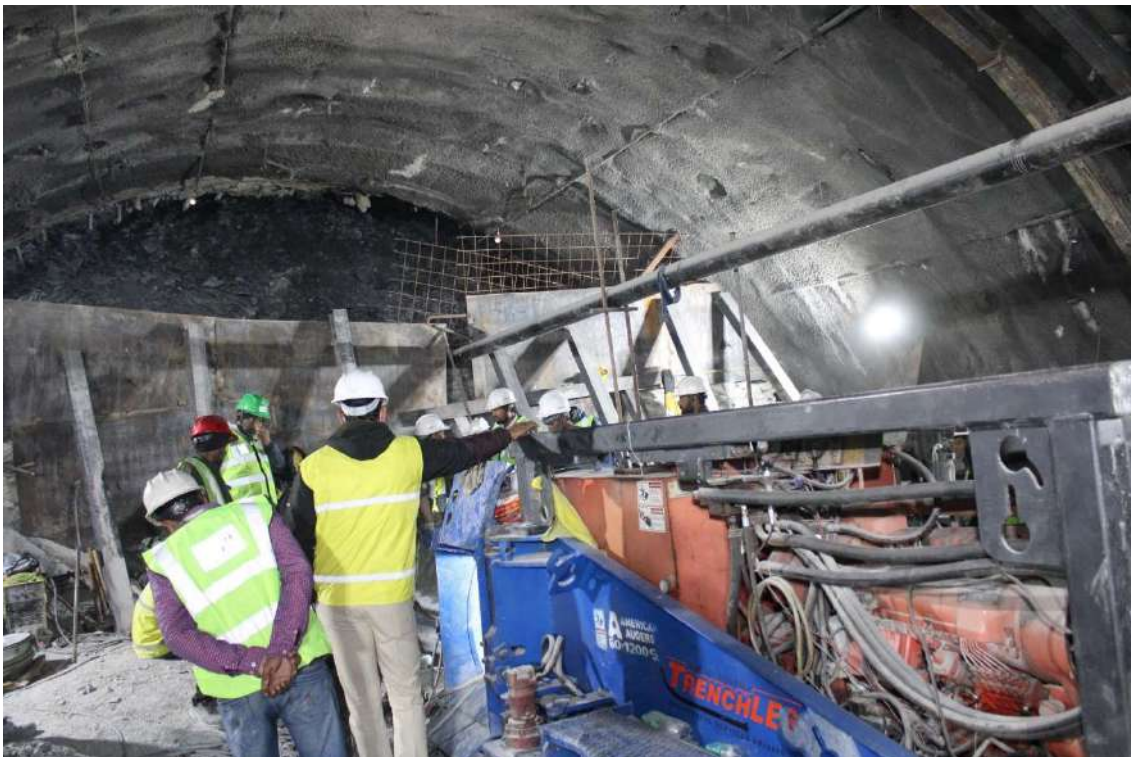
**Figure 8 shows the Horizontal Auger Machine arriving at the tunnel site and strategizing for establishment.**

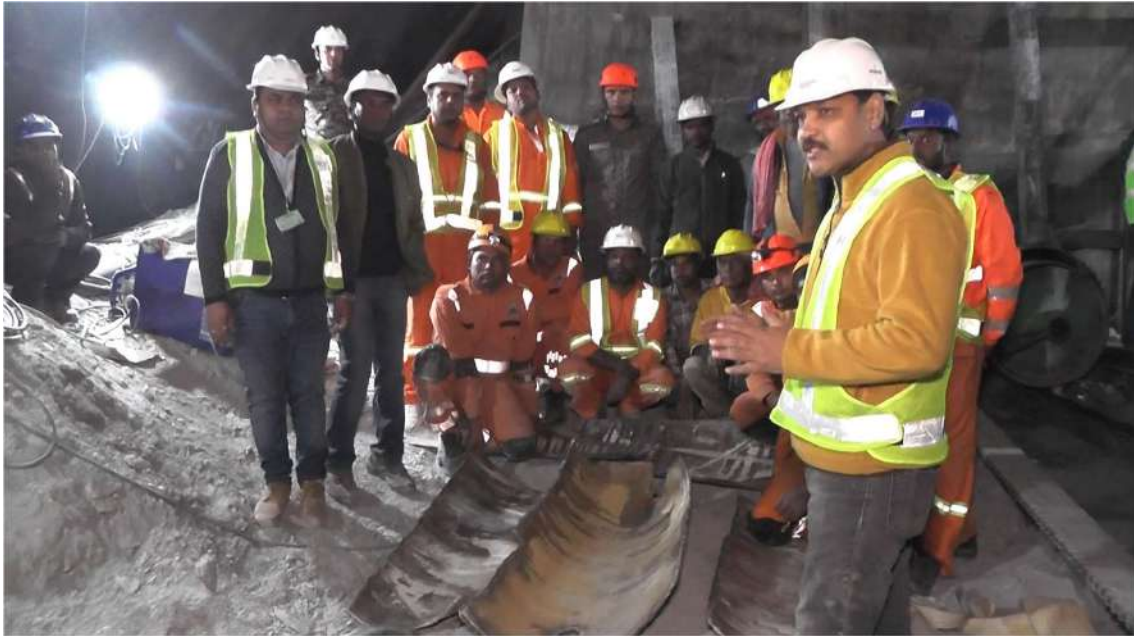
**Figure 9 Planning is underway for the removal of debris, and the procedure is being explained.**

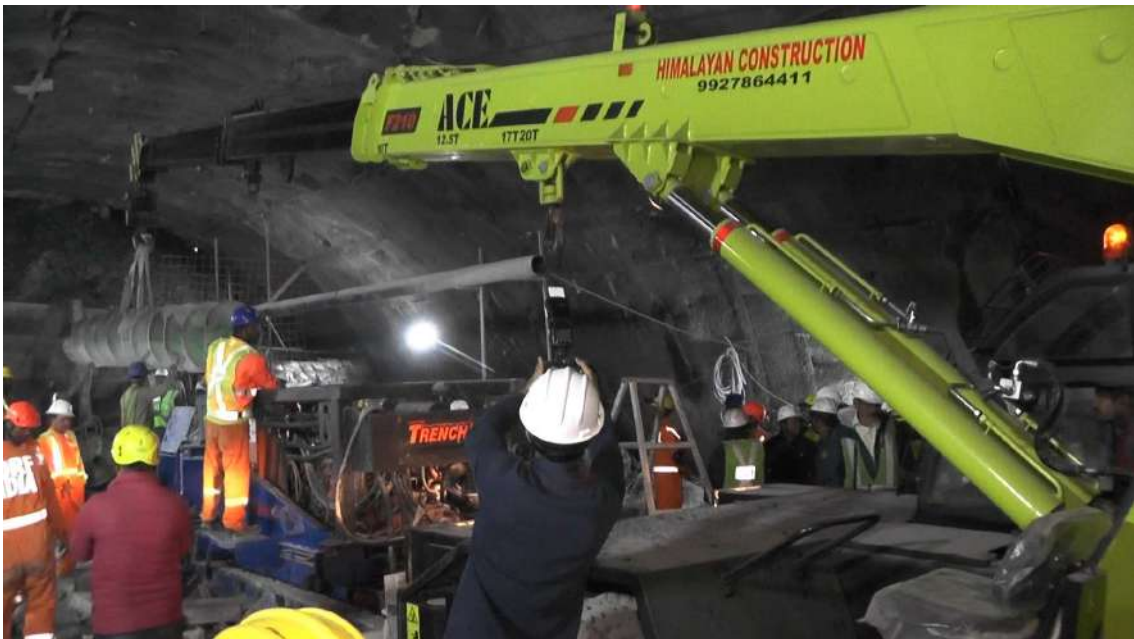
**In Figure 10, dated December 14, 2023, the Auger Machine Blade has been positioned to facilitate horizontal drillings, marking a significant step in the operational process.**

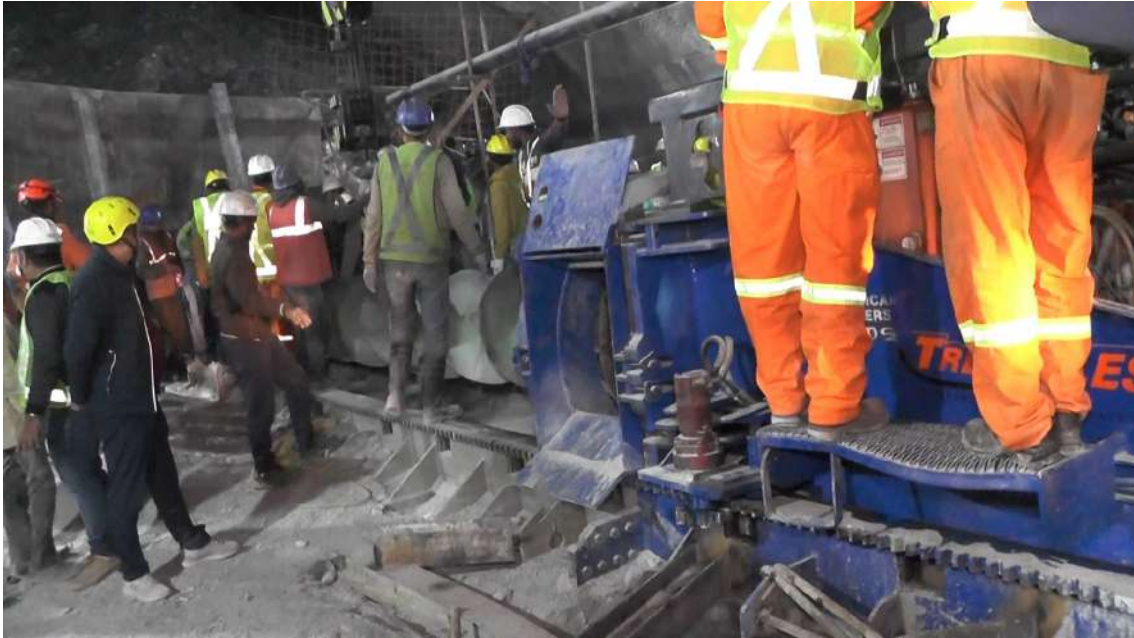
**Figure 11 captures the commencement of the Augur Machine's operation, signalling the initiation of its functional activity.**

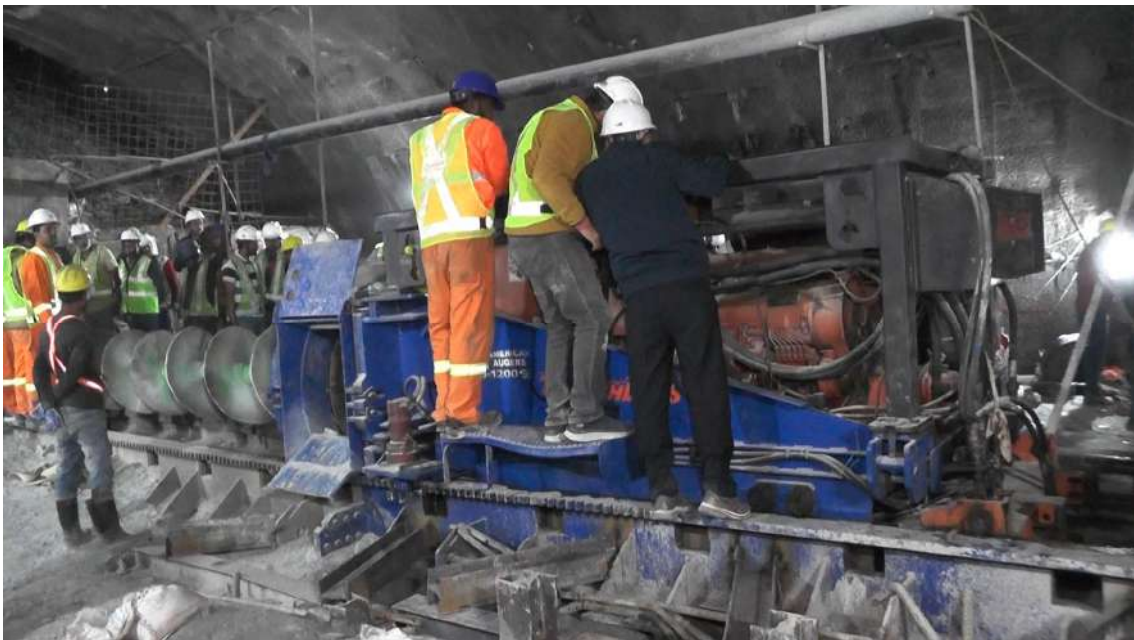
**Figure 12 captures the commencement of the Augur Machine's operation, signalling the initiation of its functional activity.**

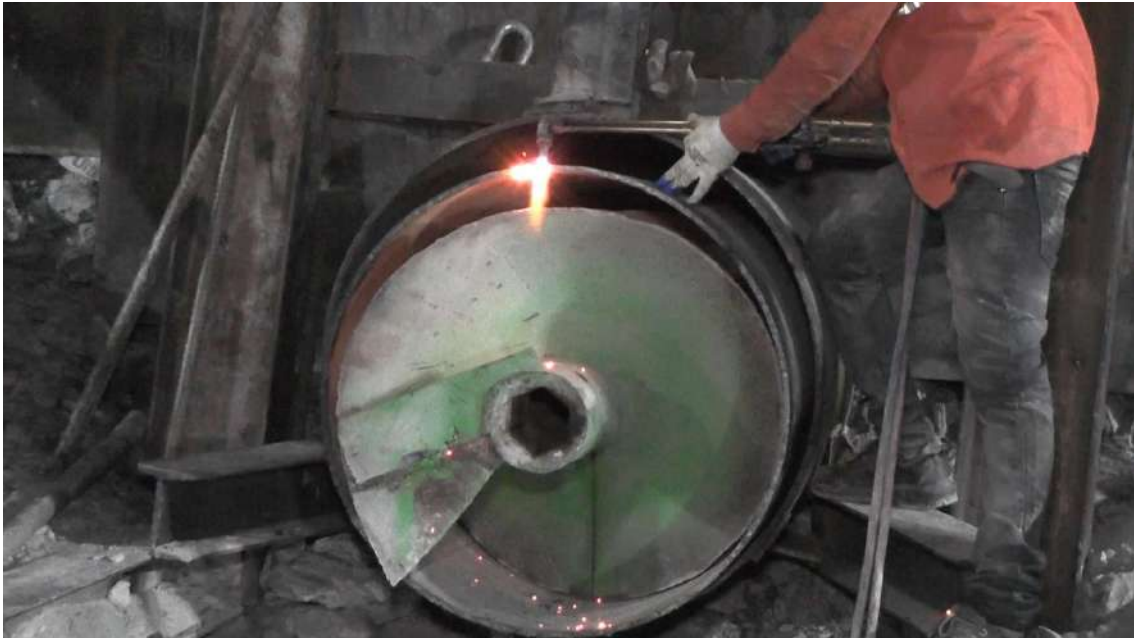
**In Figure 13, the initial pipe has been connected and seamlessly inserted, marking a pivotal stage in the bindings process.**

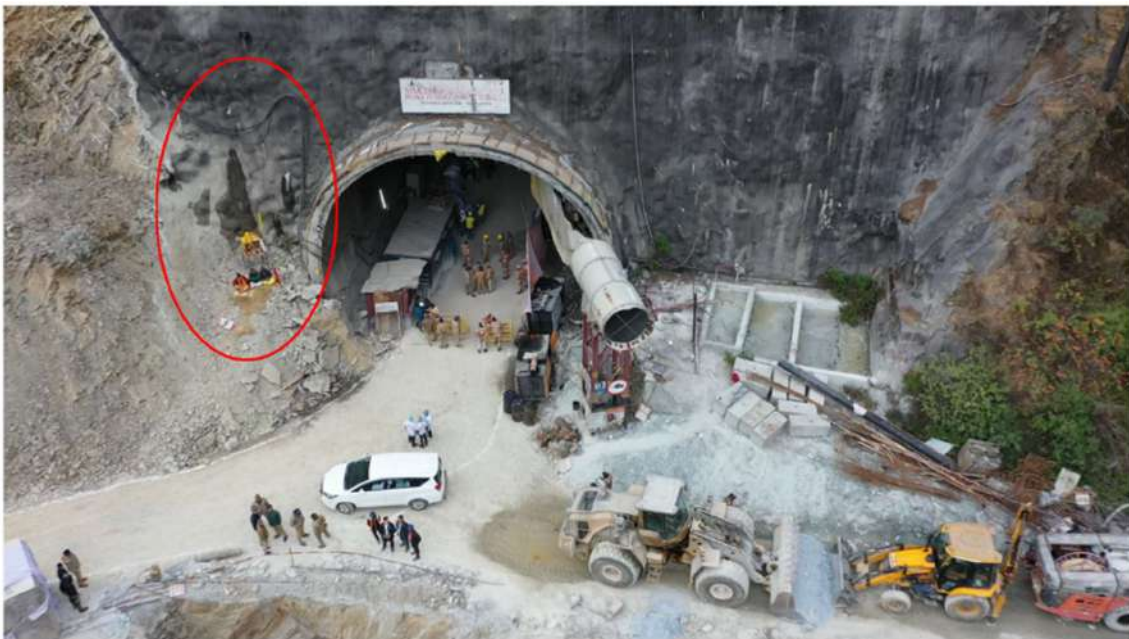
**In Figure 18**, the site is portrayed with a red-coloured circle highlighting a subtle water seepage from the ground. This minor concern was addressed promptly at that specific moment.

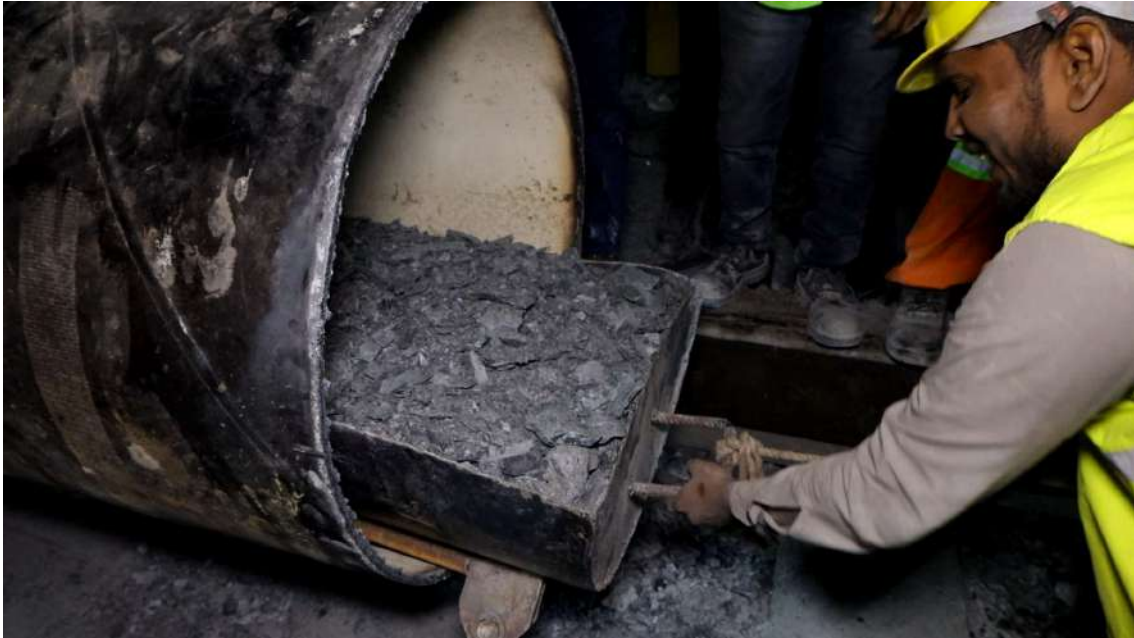
**Figure 19 illustrates the final phase of manual mining, providing a visual representation of the mining activities carried out manually in the concluding stage.**

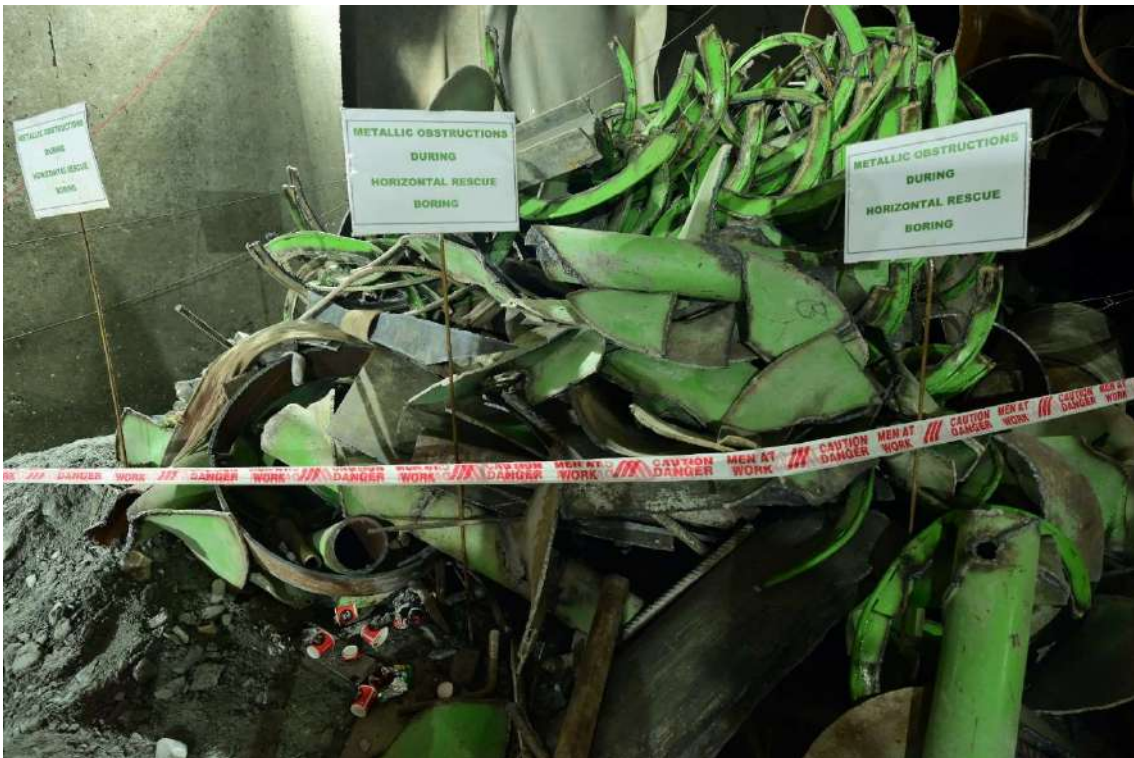
**Figure 20, The occurrence of a metallic obstruction is depicted during the process of horizontal drilling. This visual illustrates a hindrance in the drilling operation caused by a metallic object, highlighting the challenges and considerations involved in the drilling process.**

Further, the auger was required to pull back completely to assess any other damage to the pipe. On November 24, 2023, the auger was pulled out, and to assess any other metallic obstructions in the line of pushing pipe, the Ground Penetration Radar (GPR) test was carried out. Welder's team again went inside the pipe to cut the bent pipe. After cutting the damaged, bent pipe, auger reassembly was completed, and all augers were inserted. Pushing of the 10th pipe (4.7 meters in length) started on the afternoon of November 24, 2023, and a length of 2.2 meters was inserted by the evening, resulting in a total inserted length of 46.9 meters. The obstruction has again stopped the pushing of pipes.

During the cutting procedure, it was observed that manual cutting using gas cutters is the most efficient working; therefore, the gas-cutting process was resumed. On November 27, 2023, the whole length of the auger was removed. After this visual, the welders found that the cutter of the auger had been entangled with lattice girder bars, which damaged the 1.5-meter length of the 800-meter passage pipe. The remaining pipe length has been removed by gas cutting along with the obstruction caused by lattice girder, reinforcement, etc. The process was completed by the evening of November 27, 2023. After that, the shotcrete lump in front of the pipe has also been broken into pieces manually using a rock breaker.

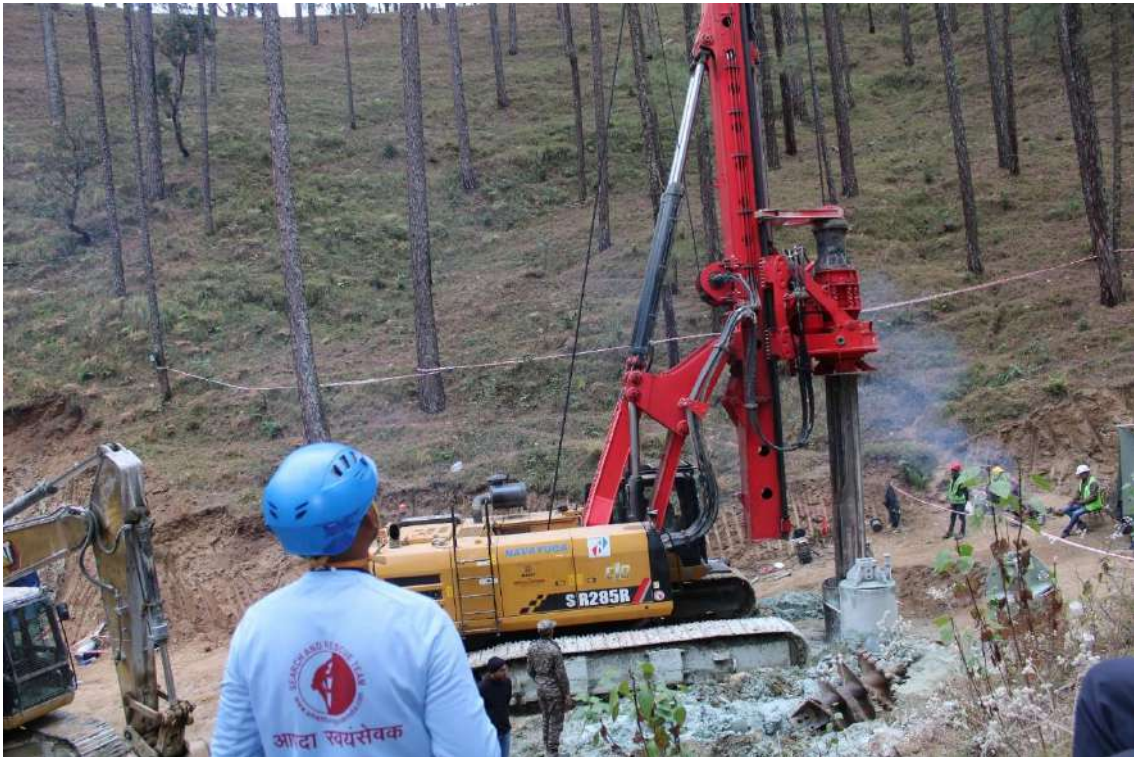
**In Figure 26, an additional plan is concurrently in progress, demonstrating simultaneous operations. This visual showcases the execution of multiple plans concurrently to achieve efficient and coordinated work.**
