# Earthquake Safe Koti Banal Architecture of Uttarakhand, India

Disaster Mitigation and Management Centre

Department of Disaster Management

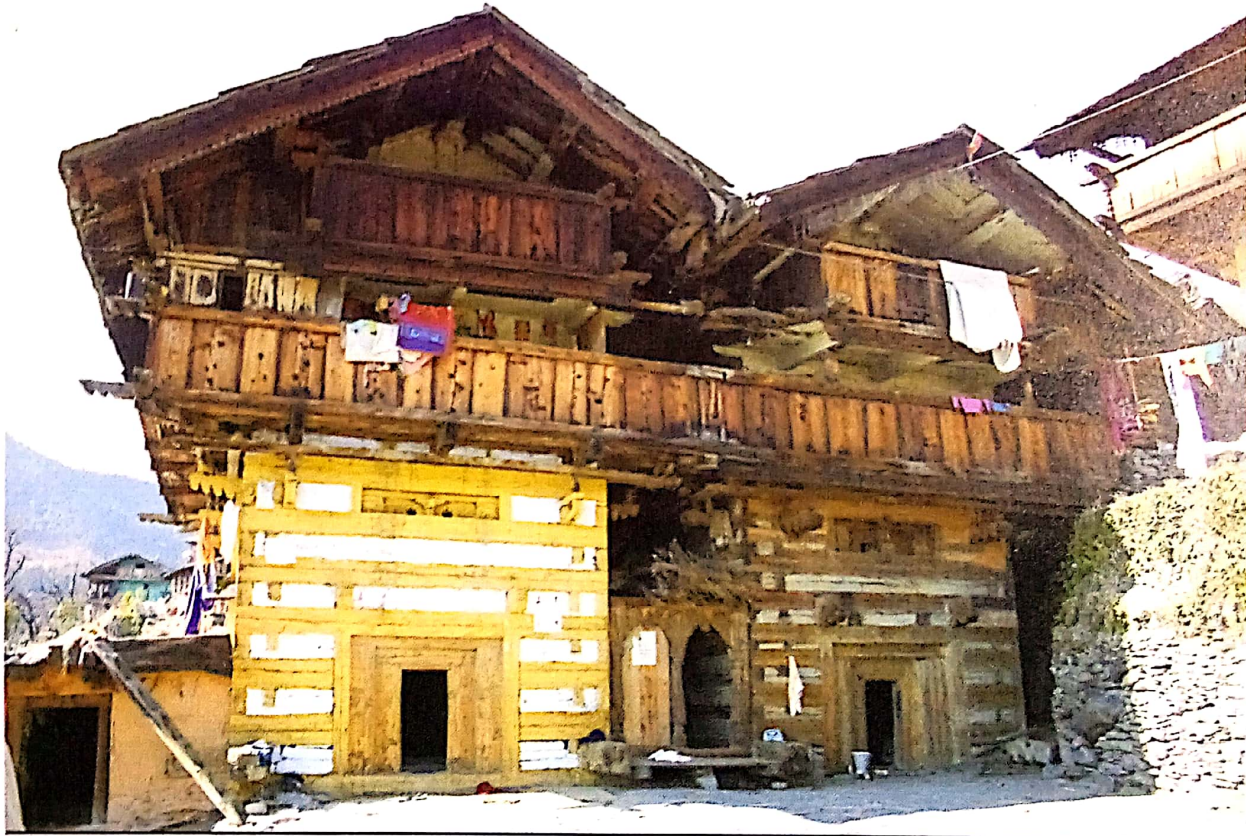
*Fig. 5: Traditional multistoried structures in Rajgarhi.*

Rajgarhi area, to the north of Barkot across river Yamuna in Uttarkahi district of Uttarakhand (Fig. 4) has a large number of intact multistoried traditional structures (Fig. 5) in a number of villages in close proximity. This area was therefore selected for detailed investigations. A structured questionnaire was prepared to assess the perception of the masses towards structural safety related aspects as also their tradition. Detailed field investigation was resorted to for assessing the structural safety related aspects of this construction style.

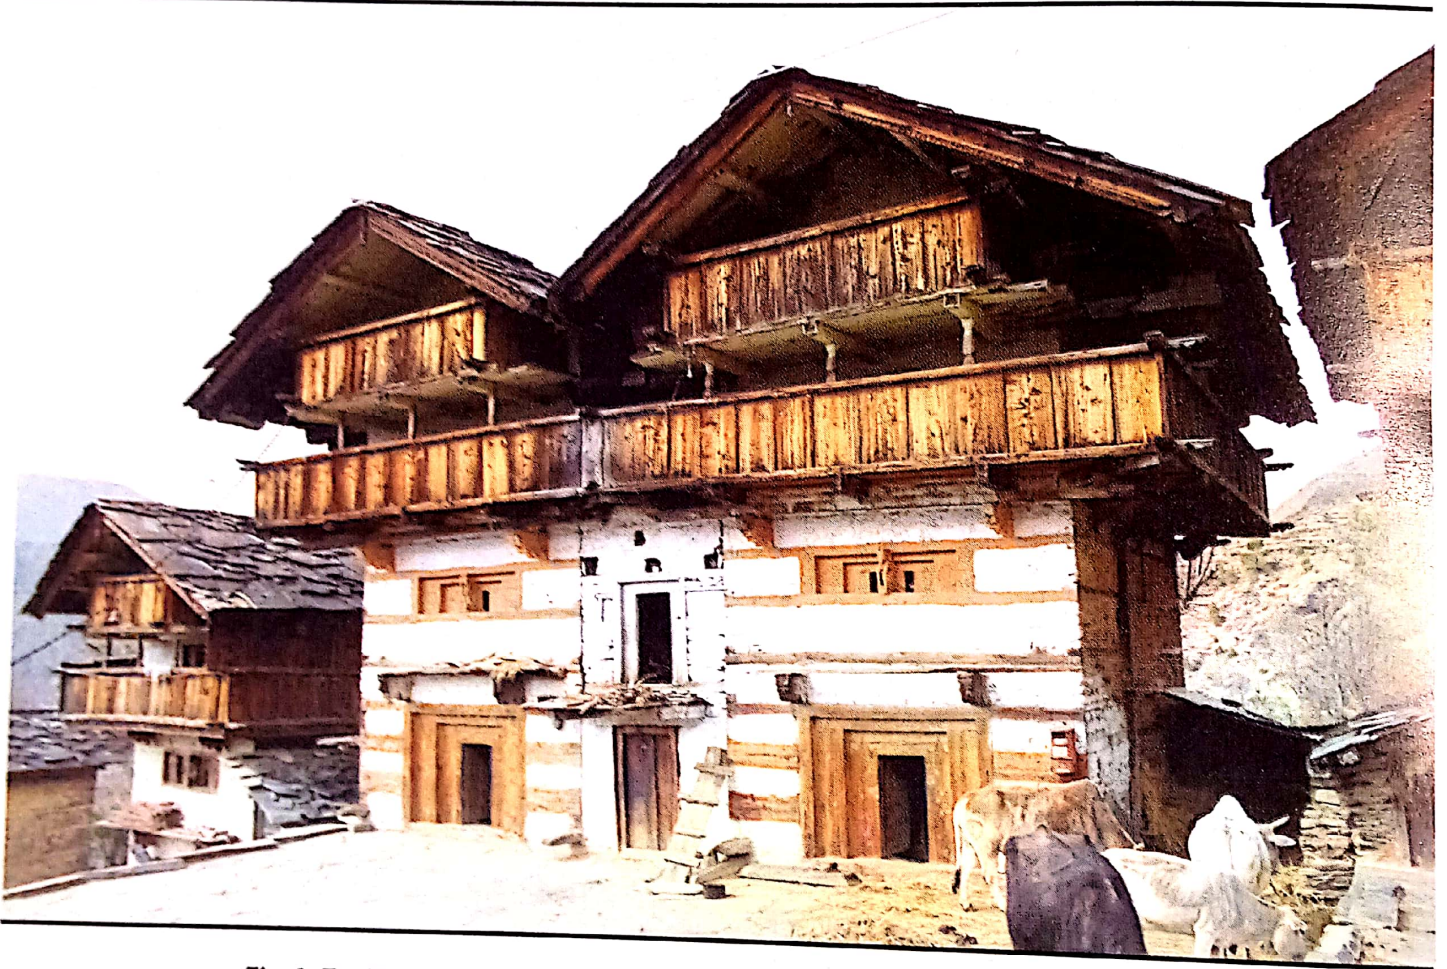
*Fig. 6: Tradition in shambles : view of the abandoned multistoried structure at Koti Banal*

It is observed that many old structures of Koti Banal style are being put to disuse and are deteriorating fast due to the lack of maintenance (Fig. 6). People are even demolishing these old structures voluntarily so as to use the disassembled building material for the construction of new and modern dwellings. Masses therefore need to be made aware and educated on the issue of protecting these heritage structures.

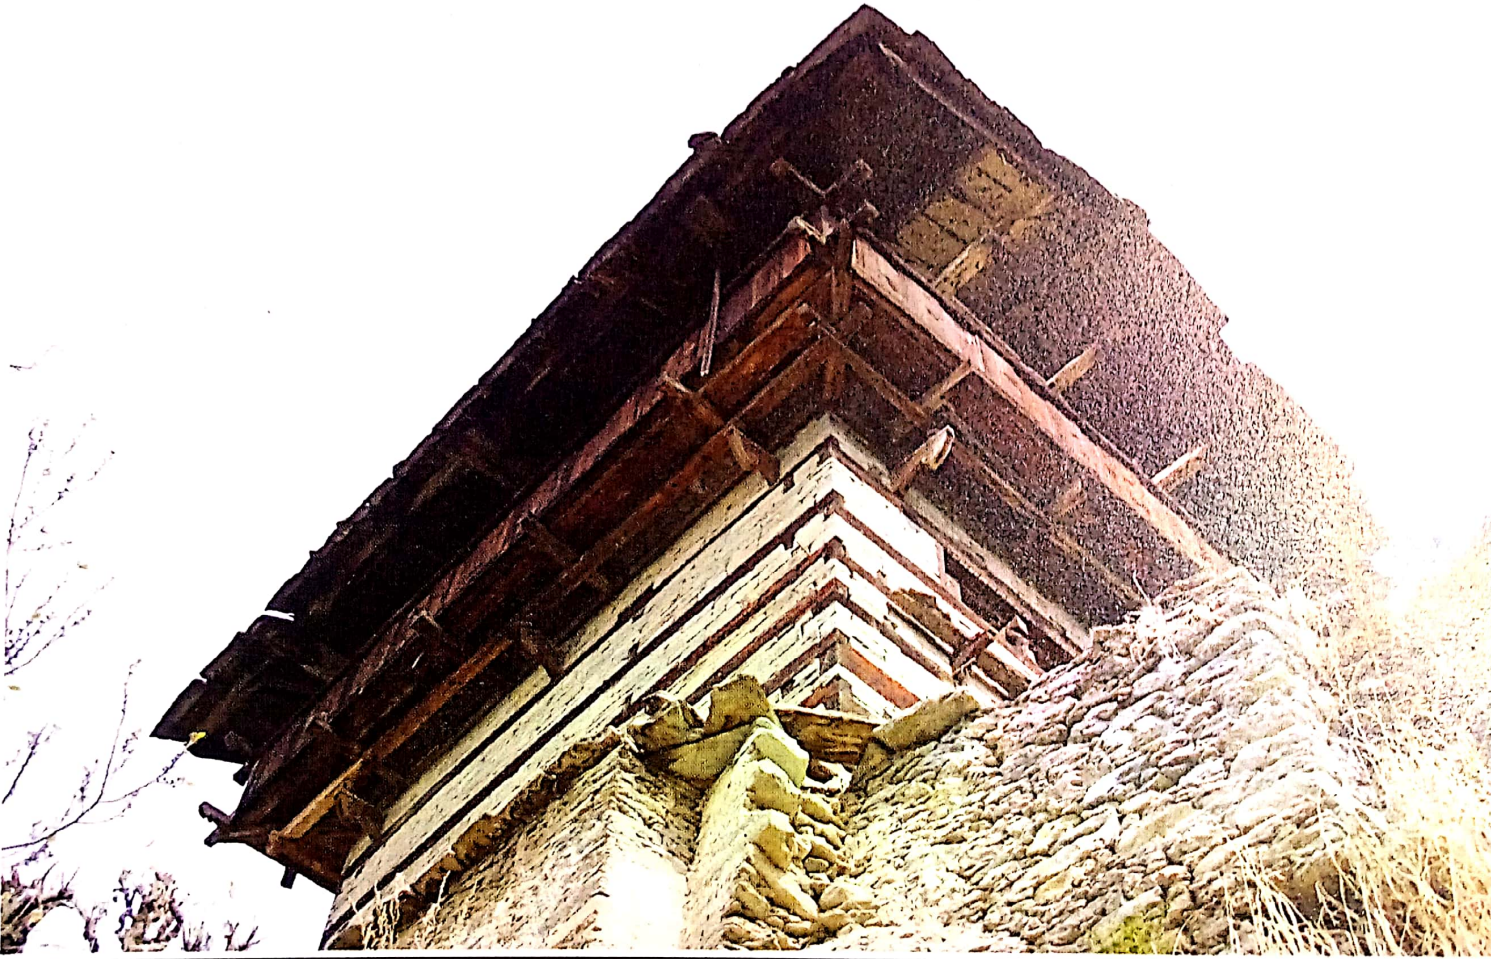
**Raised platform:** The multistoried traditional structures are observed to be constructed on raised and elaborate stone filled solid platform (Fig. 7) that is the continuation of the filled in foundation trench above the ground. In case of in situ rock being exposed the platform is observed to be raised directly over it. The height of the platform is observed to vary between 6 and 12 feet above the ground. Dry stone masonry is used for the construction of the platform.

*Fig. 7: Raised platform erected over in situ rocks to support the multi-storied structure.*

Massive solid platform at the base of the structure helps in keeping the centre of gravity and centre of mass in close proximity and near to the ground. This minimizes the overturning effect of the particularly tall structure during seismic loading.

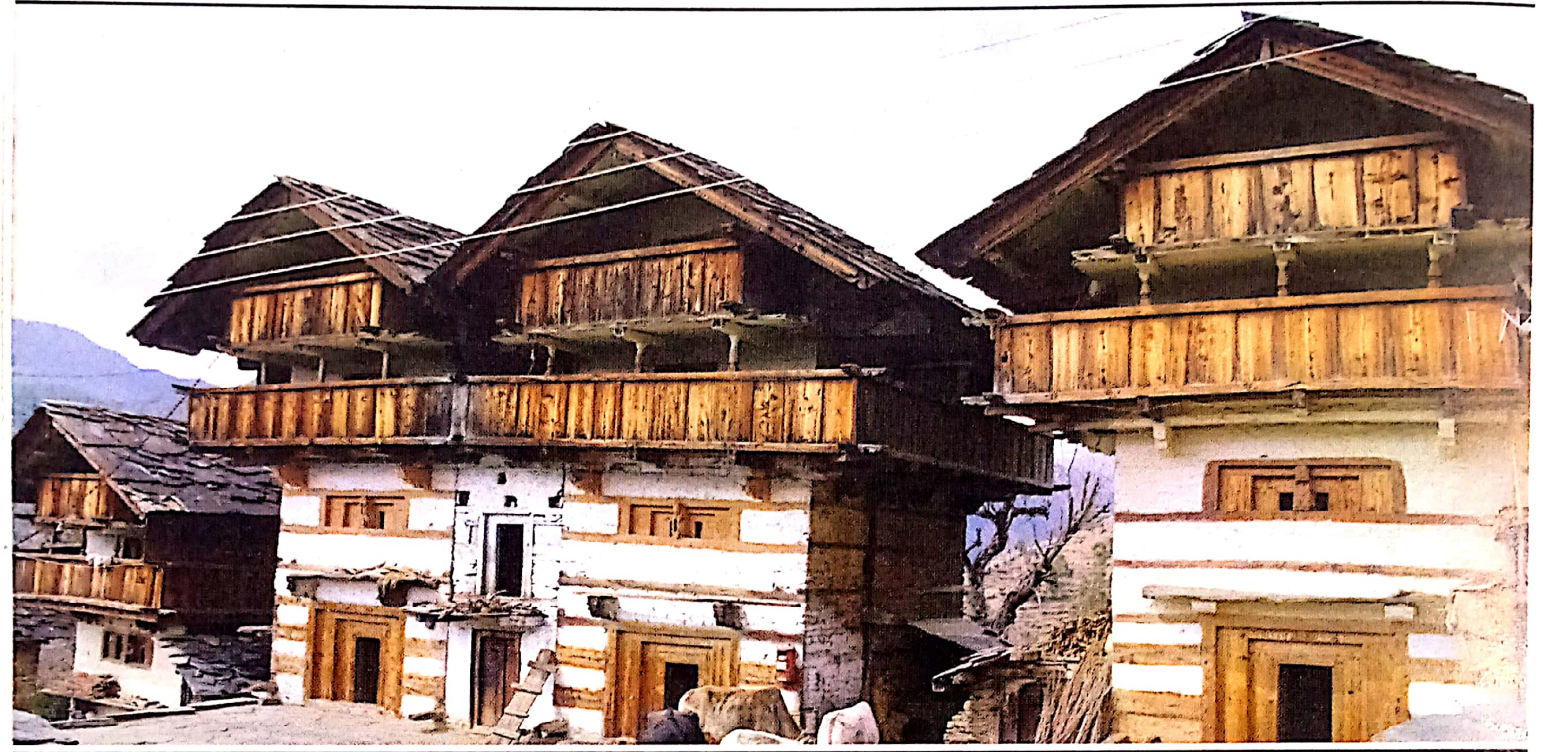
Fig.8: Simple layout of the multi-storied structures.

**Simplicity** : The structures are observed to be constructed on a simple rectangular plan (Fig. 8) with the length and width varying between 4 and 8 meters. The ratio of the two sides of the structures is observed to vary between 1.1 and 1.4.

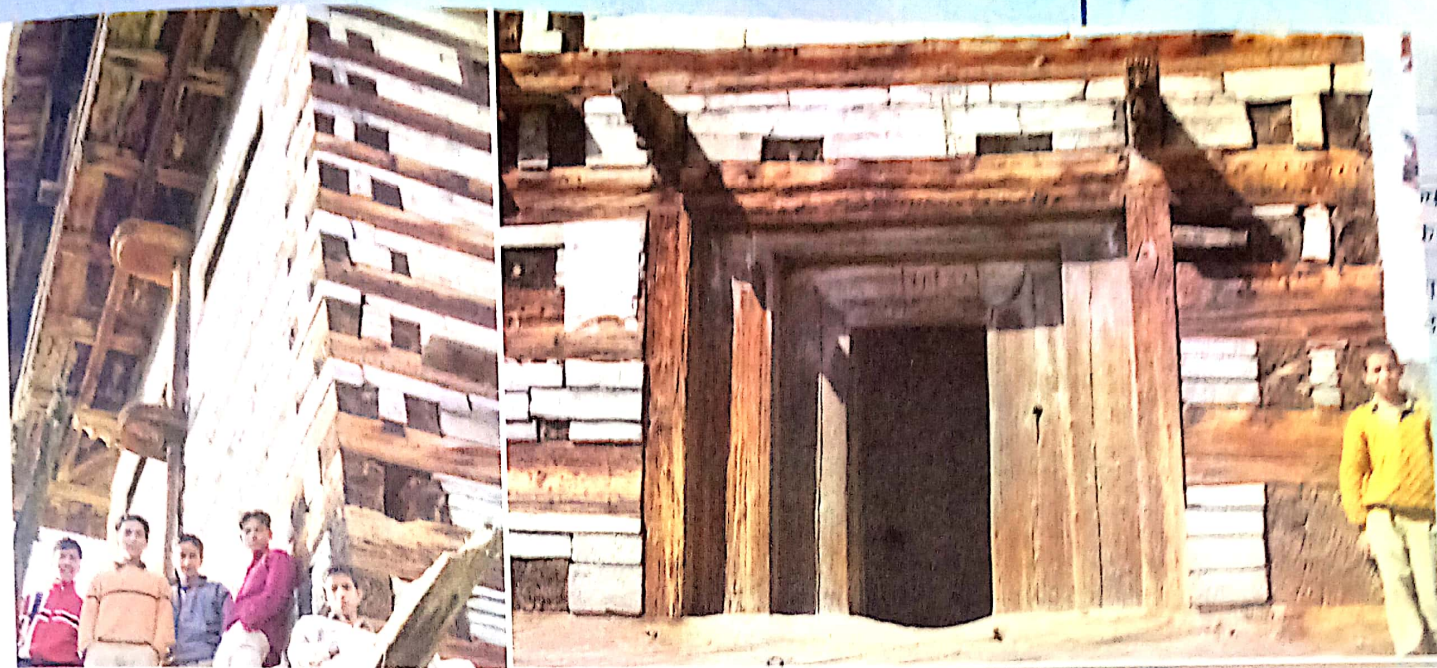
The four walls of the structure are thus raised using the wooden logs and dressed up flat stones alternately (Fig. 9). The structure is further reinforced with the help of wooden beams fixed alternately that run from the middle of the walls of one side to the other, intersecting at the center.

*Fig.9: Wood – stone architecture of the walls of the traditional multi-storied structures.*

This arrangement divides the structure into four parts and provides for joists supporting the floorboards in each floor of the building.

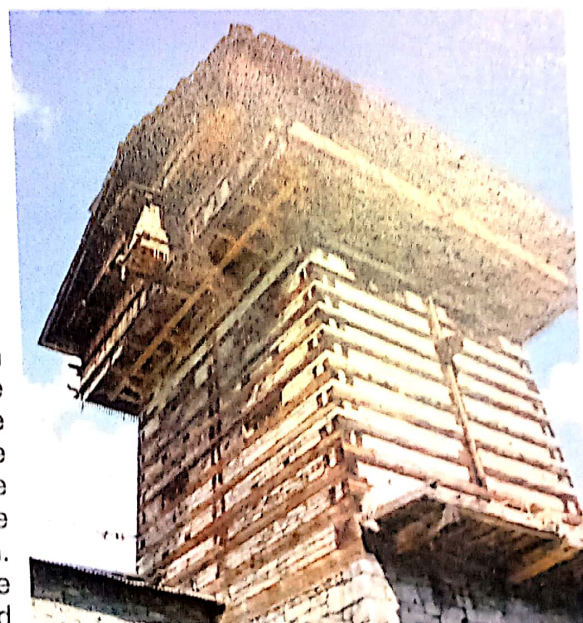
*Fig.10: The vertical wooden beam on the side walls is considered to be a seismic safety related provision.*

Salient points of the technology used in the construction of the multistoried traditional structures is also observed to be commonly used in other structures of the region as well. These include, i) the use of thick wooden logs running through the entire length of each of the walls alternately with heavy stones; ii) at the corners the edges of the pair of logs on the adjacent walls are joined together by hammering thick wooden nails through them. This has the effect of turning the structure into a single piece construction; and iii) all the windows, doorways, ventilators and floor- joists are joined to these well-secured pairs of logs and these further strengthened the structure.

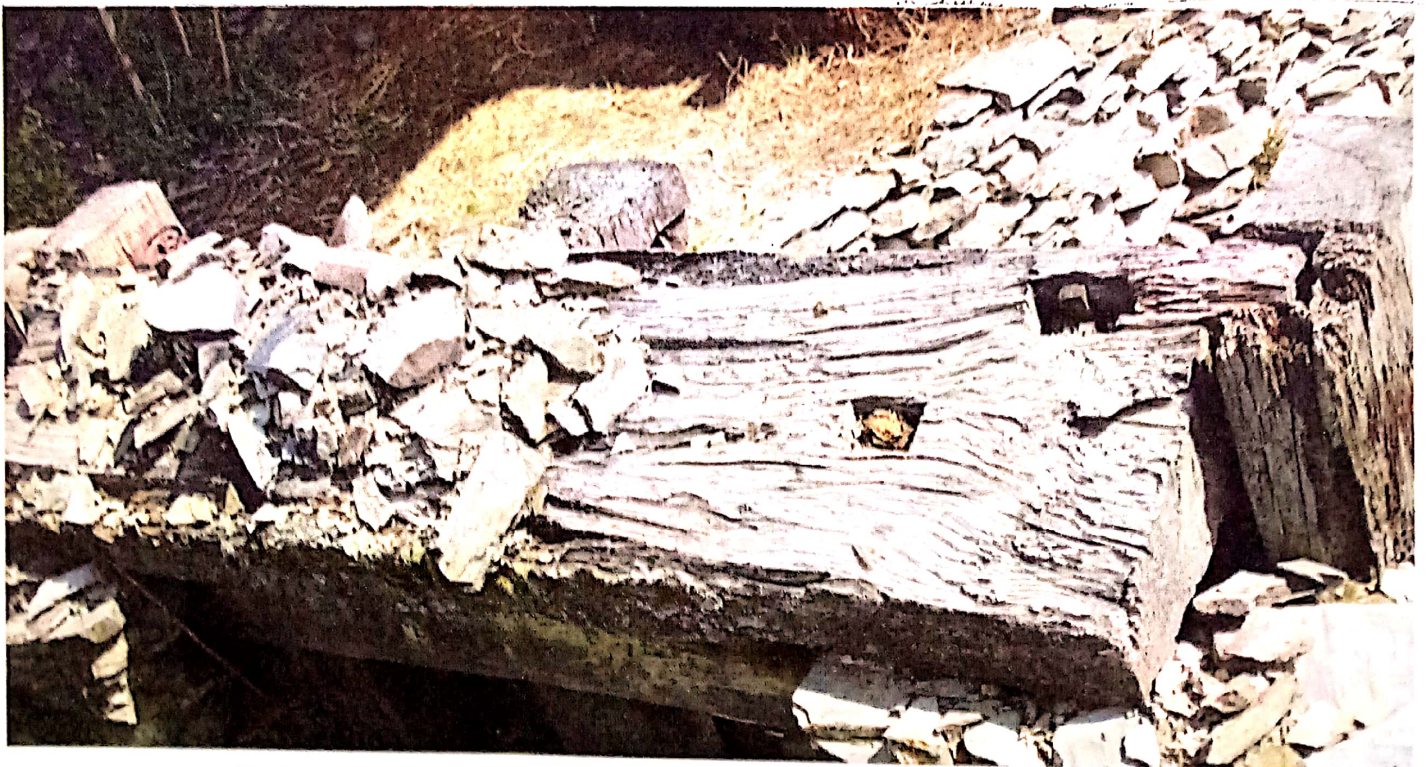
- iv) Wood is a elasto-plastic material with ability to absorb power of earthquake. Both housing and nailing techniques are resorted to for joining the wooden components incorporated in these structures (Fig. 11). This allows for minimal angular displacement. This kind of joint in the wooden beams incorporates advantages of both pin joint and the rigid joint and acts as a semi-rigid joint which is an additional advantage for shock resistance.

*Fig.11: Housed and nailed joints used for fixing the wooden components of Koti Banal architecture.*

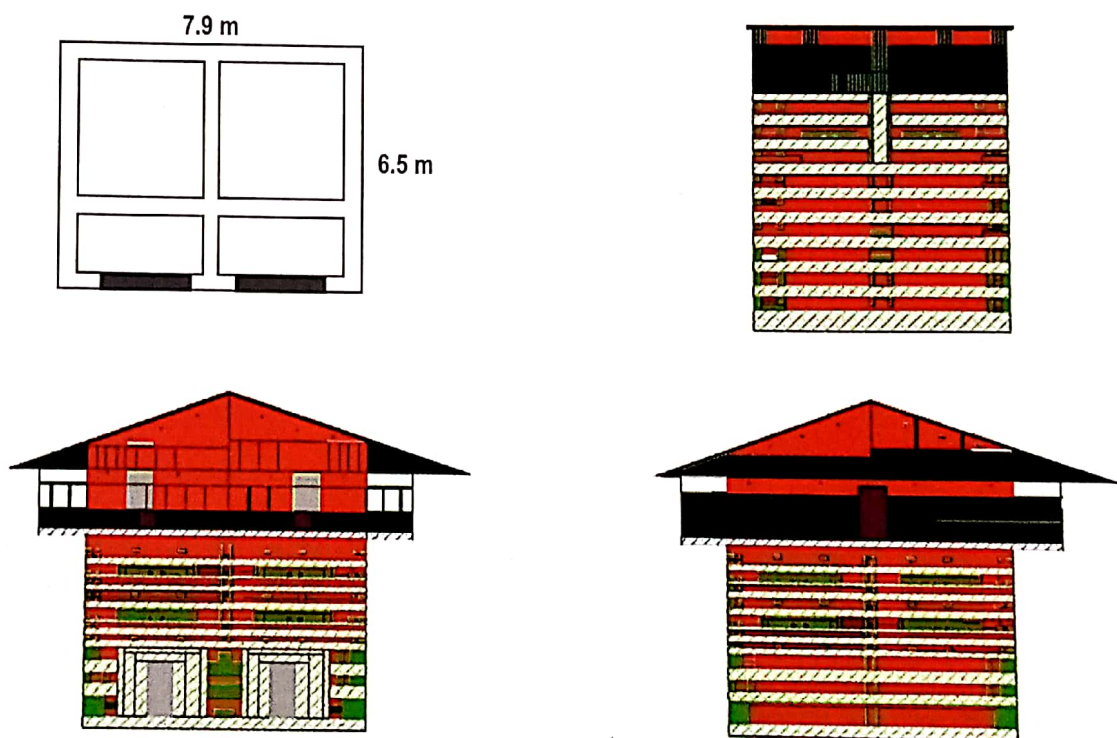
*Fig.12: Plan, side, front and rear elevations of the Koti Banal structure.*

**Equivalent static lateral force analysis of the five storied Koti Banal structure:** Most lateral forces acting on a structure during an earthquake emanate from inertia (mass) of the structures. These seismogenic forces are sudden, dynamic and can well be of immense intensity. The magnitude of lateral forces primarily depends upon the seismic zone, nature of soil or ground condition and fundamental building characteristics. The design base shear is first computed for the entire structure which is subsequently distributed along the height of the buildings based on simple formulas appropriate for buildings with regular distribution of mass and stiffness. The

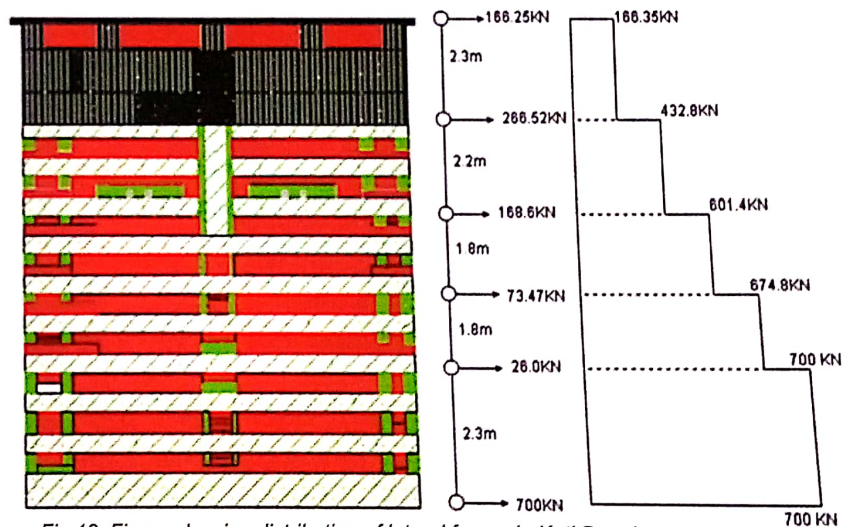
**Distribution of lateral forces :** Figure 13 shows the distribution of lateral forces in box type shear wall buildings. In order to successfully transfer the seismic forces to the ground building should necessarily have a continuous load path. The general load path for the Koti Banal structure is as follows; earthquake forces originating in all the elements of the building are delivered through the transverse walls of the building and it is bent between the floors. The lateral loads are transmitted from these transverse walls to the side shear walls by horizontal floor and roof diaphragm. The diaphragms distribute these forces to vertical resisting components such as shear walls and vertical resisting elements if any, which transfer the forces into the foundation. The diaphragm must have adequate stiffness and strength to transmit these forces. It is observed that in Koti Banal buildings the floors are made of 20-22 millimeter thick wooden planks that are expected to exhibit high degree of flexibility and all the walls are 45 centimeter dry dressed stone that are highly rigid. The above thus satisfactorily fulfill the flexible diaphragm conditions.

Fig.13: Figure showing distribution of lateral forces in Koti Banal structure

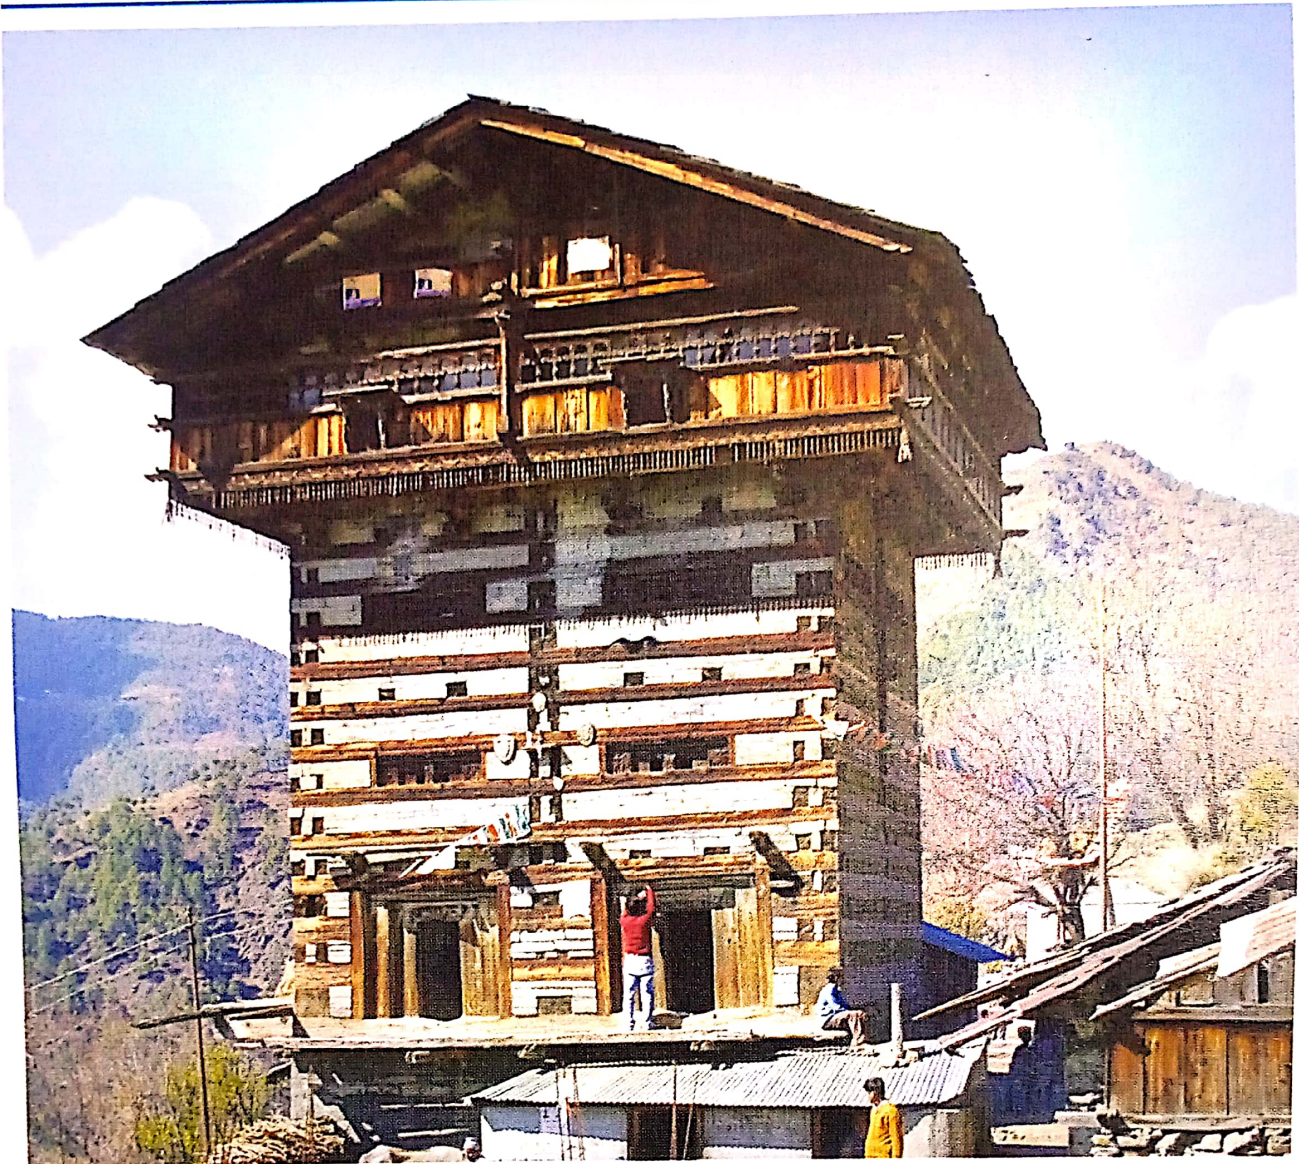
*Fig.14: New construction in front of the magnificent structure at Koti Banal would subdue the impact of the tradition*

structure at Koti Banal is observed to be the most magnificent of these buildings and therefore the architectural style is being termed as Koti Banal type. Unplanned construction taking place right in front of this structure might amount to defacing the traditional structure (Fig. 14).

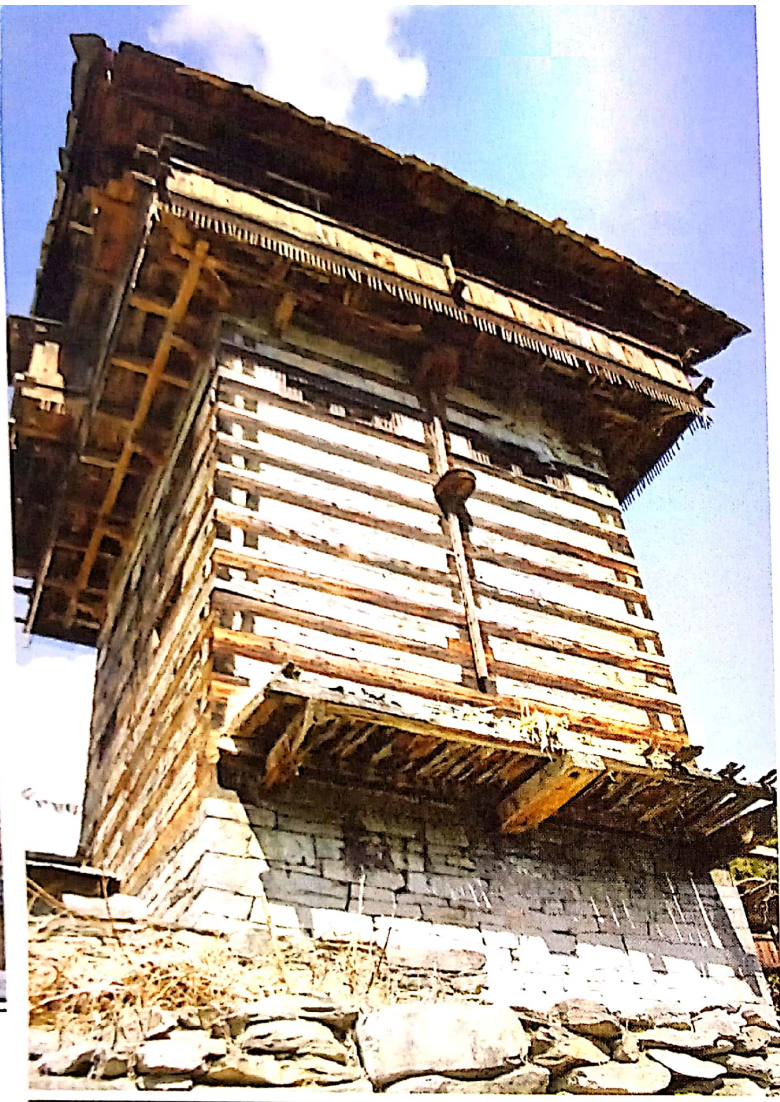
*Fig.15: View of the multistoried traditional structure at Gona.*

Equally impressive structure is observed in Gona village (Fig. 15). Detailed examination of the structure reveals that the principles of Koti Banal architecture are not strictly adhered to in this structure. The roofs of this structure are observed to be comfortably high while internal layout of the walls varied in every floor (Fig. 16). Detailed observations reveal that the basic elements of seismic safety have been compromised with in this structure.

It is observed that the middle portion of the Gona structure has bulged out which might be due to violation of Koti Banal guidelines. Collapse of the structure might jeopardize human lives.

were analysed and calibrated at Birbal Sahni Institute of Palaeobotany, Lucknow. In order to address the issue of architectural differences in the structure observed at Gona and Koti Banal wood samples from both the structures were dated using radiocarbon ( $C^{14}$ ) techniques. The Koti Banal structure (Fig. 10 and Fig. 14) was dated to be  $880 \pm 90$  years before present while the Gona structure (Fig. 15) was dated to be  $728 \pm 60$  years before present.

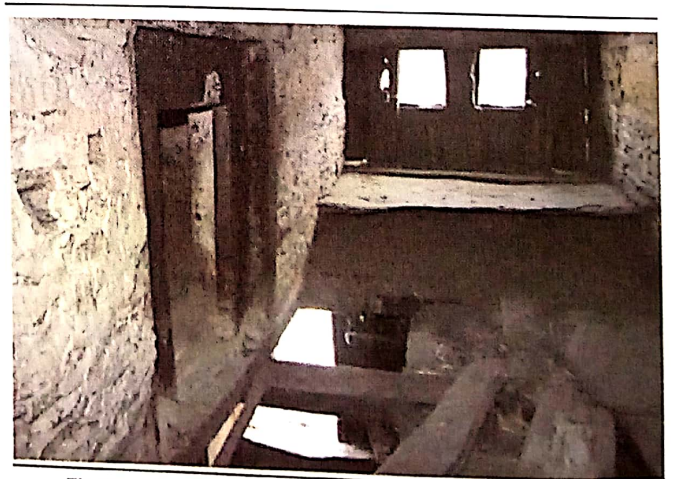
*Fig.16: Internal wall with a door on the first floor. This wall lacks continuity from the ground floor.*
